**REPORT OF DR A F ANDERSON
INDEPENDENT ELECTRICAL ENGINEERING CONSULTANT
DATED 9th May 2012**

Specialist Field : Electrical Engineering

**Subject Matter : Sudden Acceleration/Surge Incident Brandon Street,
Wellington NZ Friday 20th January 2012**

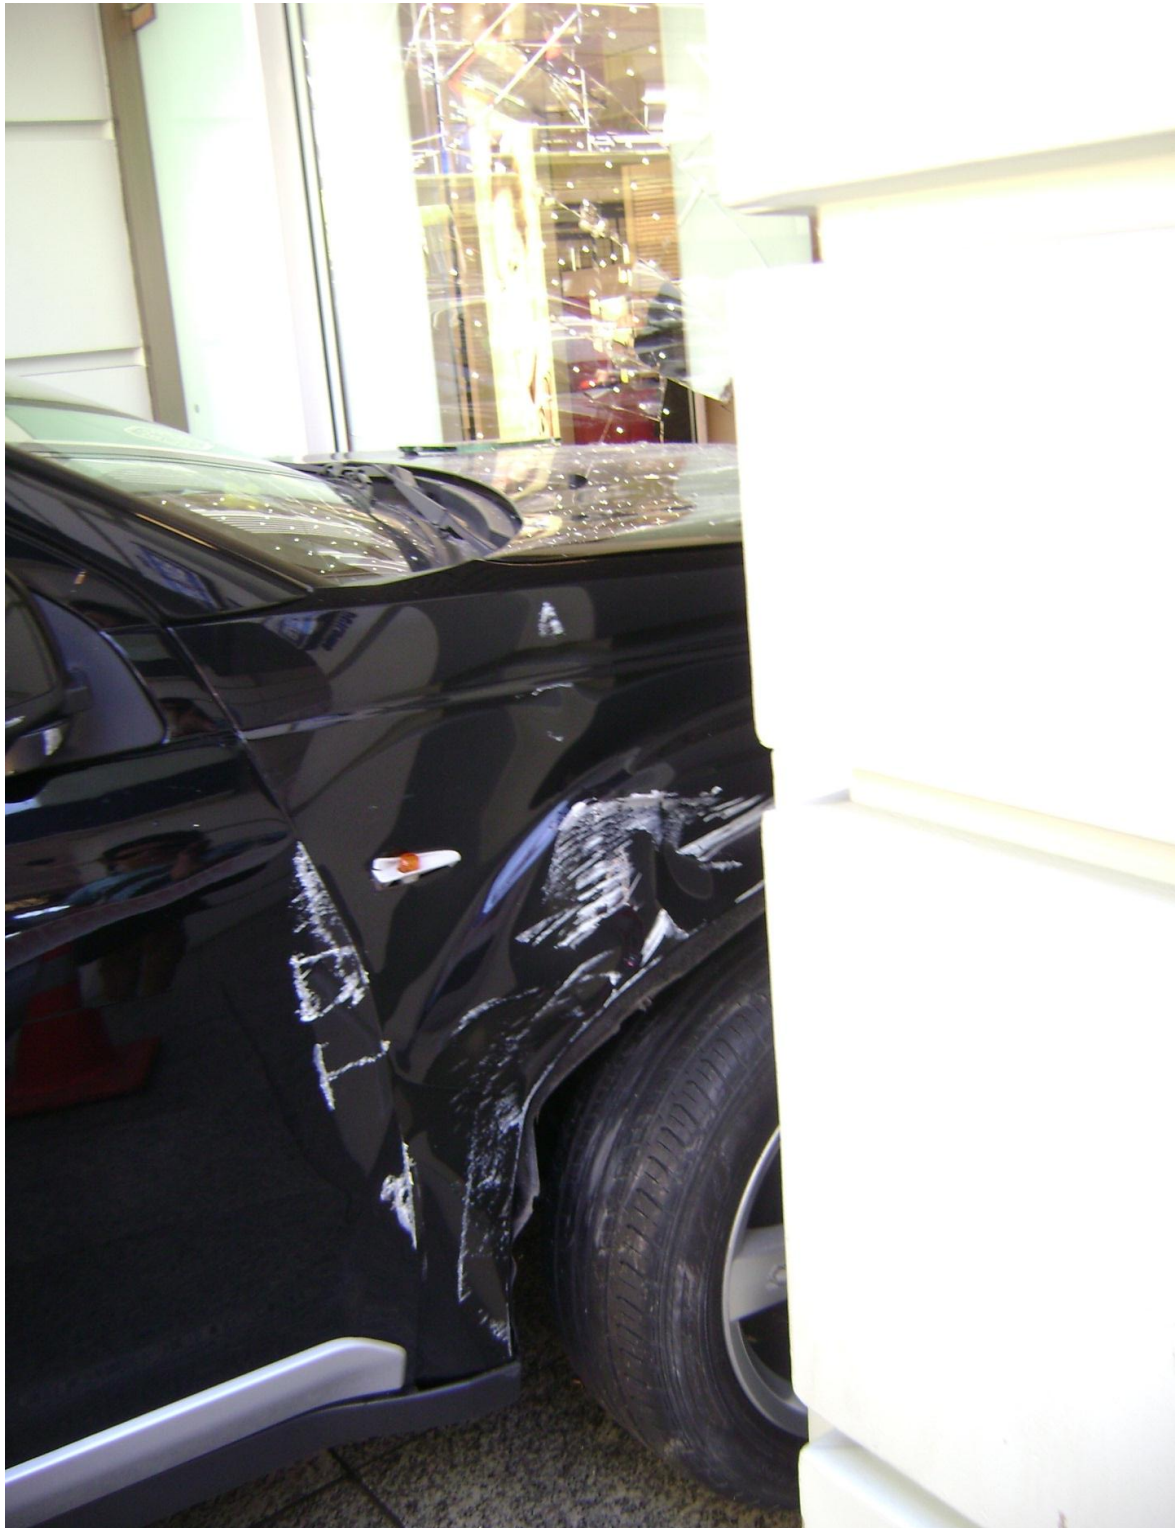
(Police photograph DSC03783.JPG)

Fig 12 Drivers side showing damage to front right wing and signs of rubbing on road surface and wall of tyre
