**REPORT OF DR A F ANDERSON
INDEPENDENT ELECTRICAL ENGINEERING CONSULTANT
DATED 9th May 2012**

Specialist Field : Electrical Engineering

**Subject Matter : Sudden Acceleration/Surge Incident Brandon Street,
Wellington NZ Friday 20th January 2012**

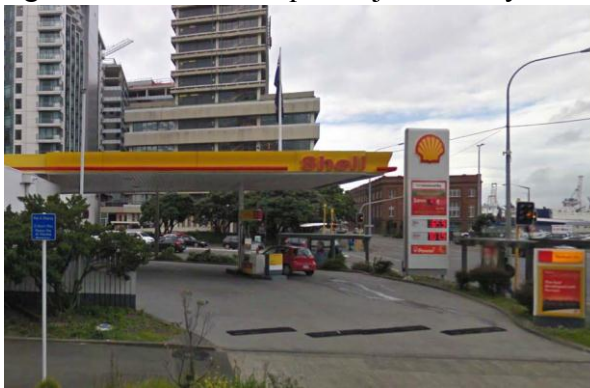
In answer to my request for any information regarding potholes and jolts etc. that the car might have experienced shortly before the sudden acceleration incident the DEFENDANT informed me in her note of 2nd April 2012 as follows: "Have remembered there was a small but sharp speed hump which was unexpectedly just inside the garage forecourt. It was quite a jolt and my mother was a bit shaken." See Fig 2.

Fig 2 Small speed humps at entrance to garage

Fig 2 above shows the small speed humps inside the garage forecourt.

¹⁴ Sometimes the shock from going over a bump or a wheel falling into a pothole can seriously disturb electrical contacts in the connectors between electronic systems and the wiring harness and battery connections. Sudden accelerations have been known to be triggered by such disturbances. For example NHTSA ODI Complaints 10316132, 10314982 for Toyota Prius vehicles.. In this instance there is no indication of any kind of change in vehicle behaviour after upon going over the bump.

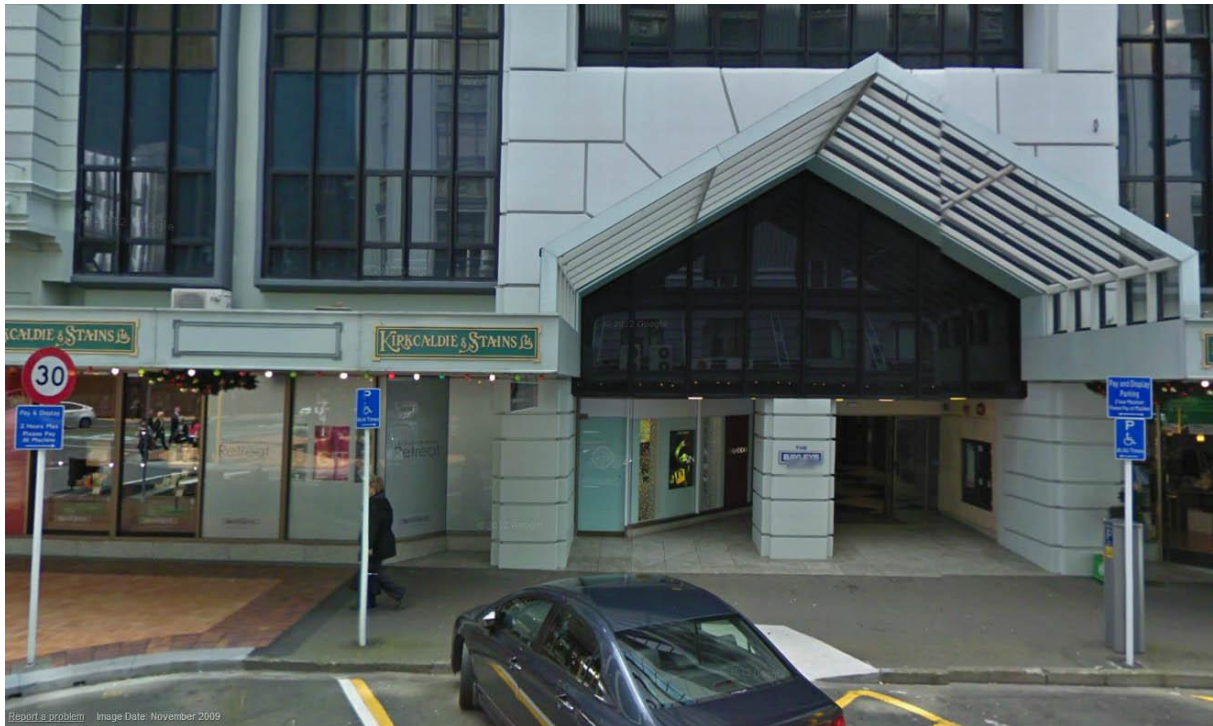
Fig 8a Entrance to Bayleys Building (Google Earth)

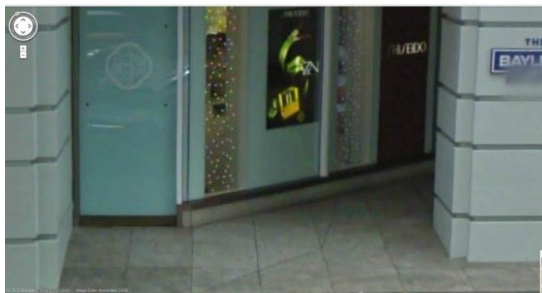
Fig 8b Window & Pillar (Google Earth)

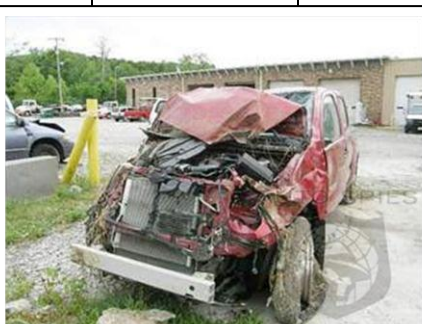
Fig 23 Tacoma after 5th sudden acceleration incident**Table 2 Extracts from NHTSA Complaints Database for 2007 MY vehicles See also Appendix 3**
