## Redaction in the 2011 NASA Report 'NHTSA Toyota Unintended Acceleration Investigation'

Prepared by Dr A F Anderson CEng FIEE

February 10<sup>th</sup> 2011

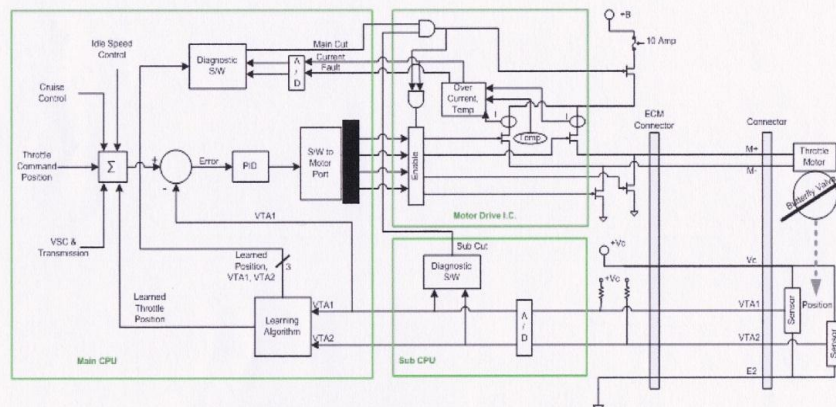
**Figure 6.6.1.1-1. Throttle Valve Control Block Diagram**

The throttle control loop maintains the throttle motor at the commanded throttle position based on throttle position sensor feedback. The throttle functional block diagram that describes this operation is shown in Figure 6.6.1.1-1. The control loop consists of six major components: 1) the throttle motor and its associated mechanisms, 2) the motor drive IC, 3) two throttle position Sensors, 4) the Sub-CPU, 5) the Main CPU, and 6) the software for both the Main and Sub-CPU. Refer to Figure 6.7-1 for the Software Block Diagram.

Once the Main CPU determines the desired throttle drive position, it outputs the commands to the H-Bridge on four signal lines (redacted). The circuit path from these four lines to the actual motor winding is an important electrical area to review since it is beyond the direct CPU control yet faults exist which can drive the throttle valve motor. Faults in this area are captured by either over current and/or over temperature sensing. The throttle valve motor is a DC motor that operates on PWM drive to control the current delivered to the throttle motor and thus control the throttle valve position. The PWM signals are supplied thru the M+ and M- lines which can supply pulses of either polarity to the motor by an "H-Bridge" circuit. The throttle valve is counteracted by a spring, and upon removal of power to the throttle motor, the throttle valve will return to its "spring detent" position (6.5 degrees above fully closed position).

| Page | Ref | Detail | Comments |
|---|---|---|---|
| 87 | 6.6.1.1 | Throttle Position Control Functional Area 6.6.1.1 Detailed Implementation:<br>Fig 6.6.1.1-1 Throttle Valve Control Block Diagram one area blacked out. 4 blackouts in description below diagram | Why, considering that it is the electronic throttle that this whole investigation is about, black out part of the functional diagram? Is there some kind of functional deficiency that someone does not wish to draw attention to |

The IC also has a signal from the Sub-CPU and a different signal from the Main CPU that can inhibit PWM drive signals to the H-Bridge, as shown as inputs to the Motor Drive I.C. in Figure 6.6.1.1-1. Also, certain sensed voltage conditions can trigger an IC reset with PWM drive signal inhibit.

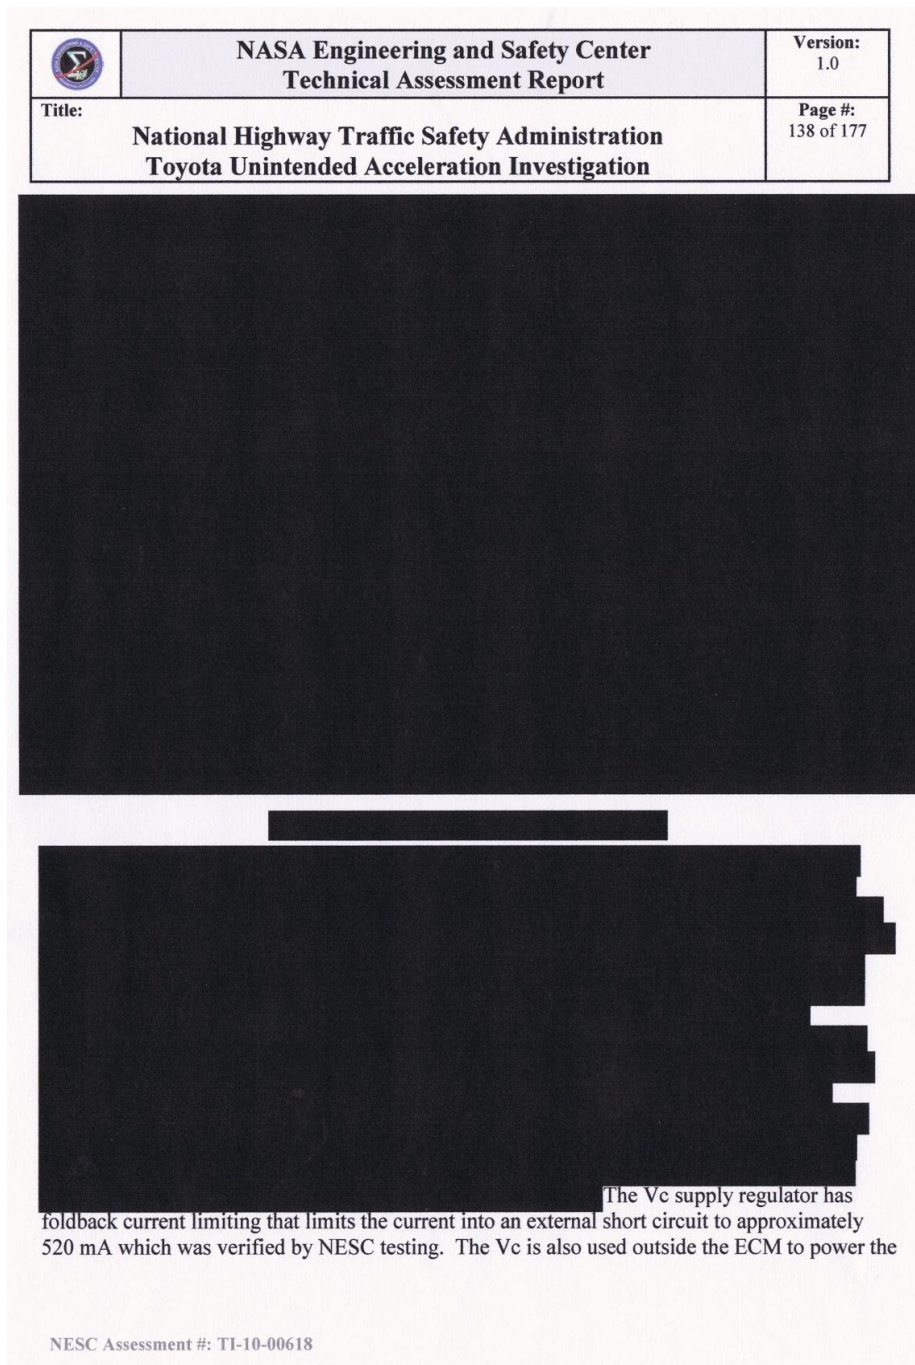
**Fig 7 Page 138 Relates to ECM Power System**

Why is it necessary to hide almost all the information about the ECM Power System? Note that Vc is used to power both pedal sensors and both throttle sensors AND other vehicle sensors. As I understand it, the accelerator pedal sensors are supposed to be driven from independent supplies, likewise the throttle sensors. Here we have all four driven from the same supply.

| 138 | 6.6.7.1 | ECM Power System : 6.6.7.1 Detailed implementation Description Almost the entire page blacked out -presumably a diagram "Fig 6.6.7-1" and text | SEE INDEX P7 WHICH REFERS TO Fig 6.6.7-1<br>What was in the diagram that required that it be covered up and hidden from view? Presumably Toyota did not want anyone outside NASA to see the diagram. |
